# Common Marine Inspection Document for Small Workboats

**IMCA M 189 (eMISW) Issue 6.1**  
**December 2022**

**Thor**  
**8438631**  
**05 Sep 2023**

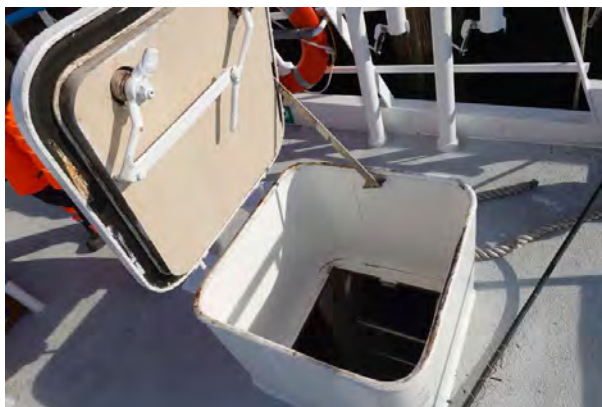
Inspector There is no indication of any water ingress. Hatches can be properly secured.  
Packing on weather tight doors found in good condition.  
Note: sealing surfaces need attention (See Summary Page).

- SART battery will expire 10/2023.
- Ventilation closing sealing edges need attention.
- Net store; house-keeping to be improved. Access to spare anchor to be cleared of various gear.
- ER spaces; house-keeping to be improved.
- Stickers to be placed on Net store access hatch, identifying SOPEP kit and Quick Closing valves.
- There is some oil in Bunker manifold save-all.
- Mooring bits are not marked with SWL.
- Emergency exit from ER space to be identified from outside.

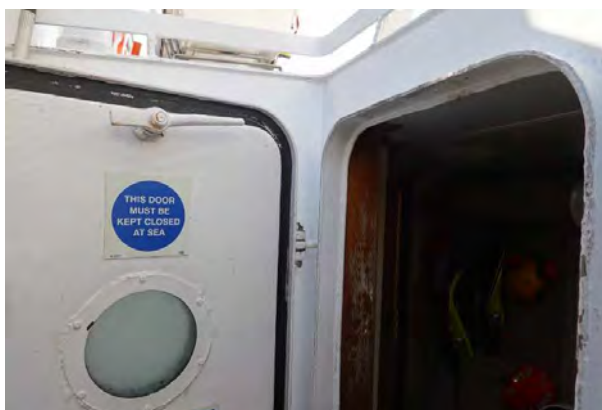
Inspector Weather tight doors are in good condition and closing tight.

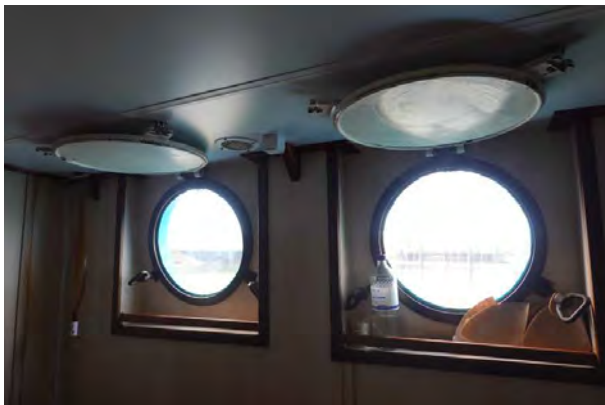
<b>5.5</b>	Can all opening port-lights be effectively secured?	Yes	No	NA *	NS
Inspector	<p>There are no opening port-lights below water level or in accommodation spaces. Port lights in crew cabins and mess / kitchenette can be properly closed / secured by steel covers.</p>

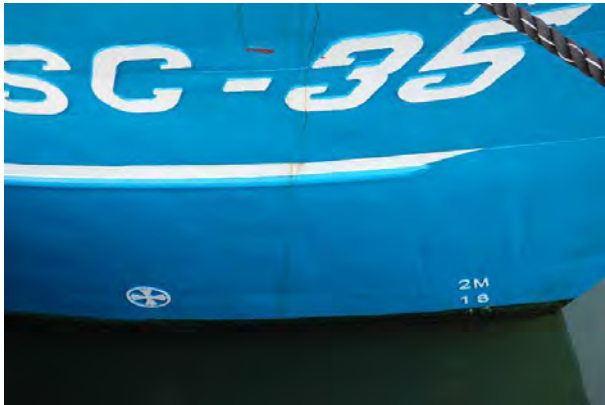
<b>5.7</b>	Does the hull and structure of the vessel appear in a good state of repair?	Yes *	No	NA	NS
Inspector	Vessel's hull and structure, in general, appears in good condition, well coated.

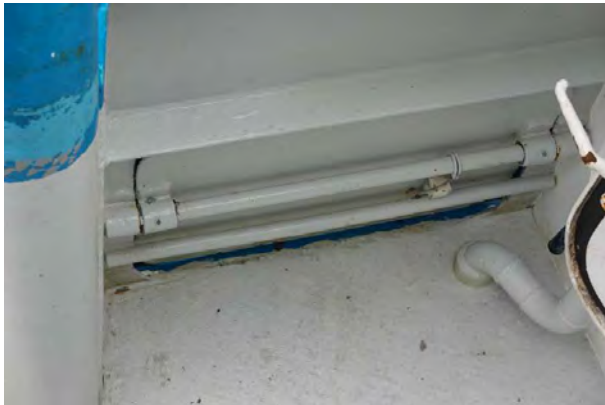
<b>5.8</b>	When a deck is fitted with bulwarks such that water may be trapped, are there effective draining ports?	Yes *	No	NA	NS
Inspector	Water cannot be trapped on deck.

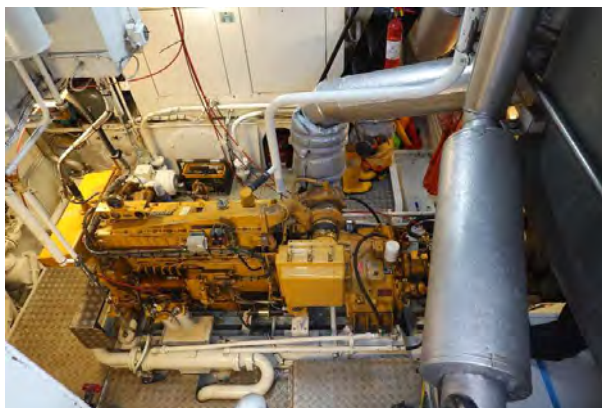
Inspector ER spaces are, in general, clean and tidy.  
Machinery consists of  
1 x ME Caterpillar 3406C, 224kW  
1 x DG set Port side: Perkins 60 kVA  
1 x DG set Stbd side: Perkins 60 kVA, in sound-proof container.  
[View of the ER space from Emergency Exit]

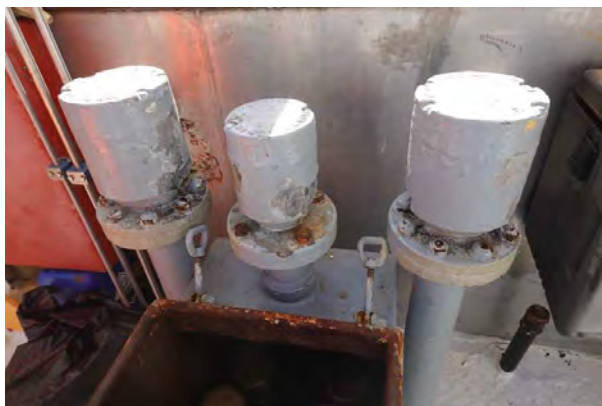
Inspector FO tank vent pipe is protected against water ingress.

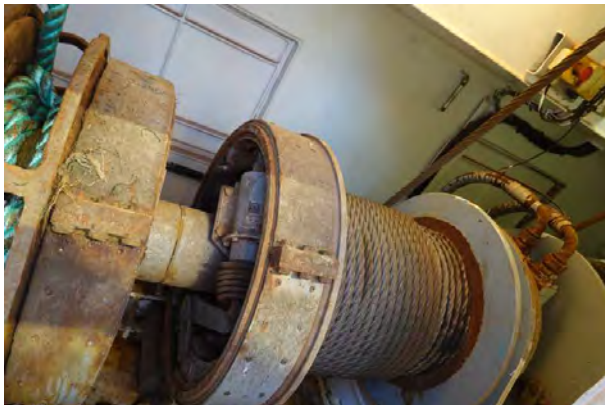
<b>6.4</b>	Are there means available to effectively control fuel spillages or leaks from permanent or temporary equipment?	Yes *	No	NA	NS
Inspector	<p>No leaks seen on the hydraulic equipment on deck. Hydraulic hoses were in good condition. SOPEP kit on board - in Net Store. [View of the winch room. No hydraulic leaks sighted, Hydraulic hoses appear old but and leakage would be contained as this is an enclosed space.]</p>

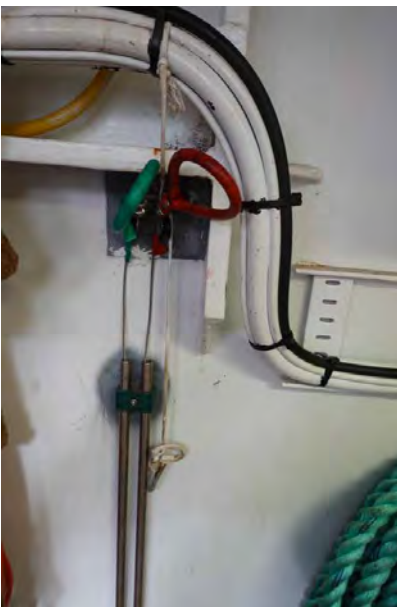
<b>6.5</b>	Is there a safe means of isolating the fuel supply in the event of an emergency?	Yes *	No	NA	NS
Inspector	<p>Quick closing valve (operated from Nets Store). Note: There is no indication on the Nets stores access hatch that QCVs are located inside the space (see Summary page).</p>

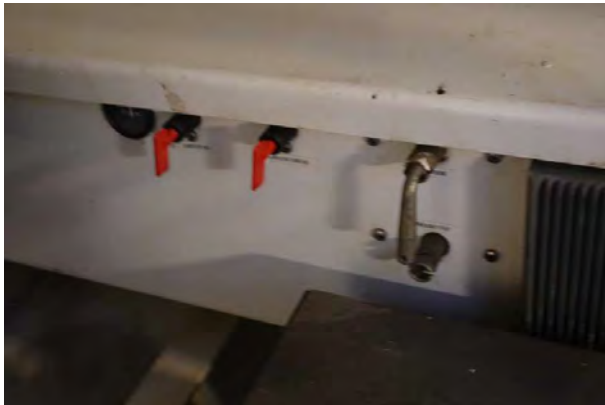
<b>6.9</b>	Are there safe means of isolating electrical supplies?	Yes *	No	NA	NS
Inspector	On Main Switch Board and on the Batteries box (on photo).

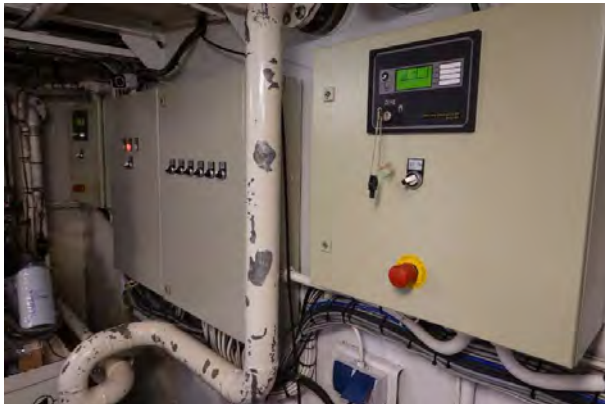
<b>6.10</b>	Are electrical systems protected from water?	Yes *	No	NA	NS
Inspector	Main switch board located in ER space.

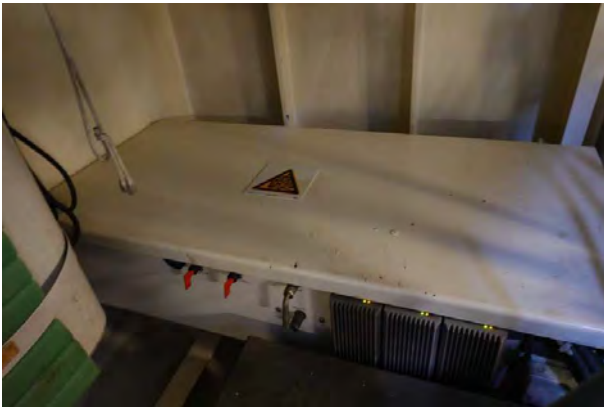
<b>6.12</b>	Are all batteries secured firmly to prevent movement?	Yes *	No	NA	NS
Inspector	Batteries are in box, fixed to ship's hull.

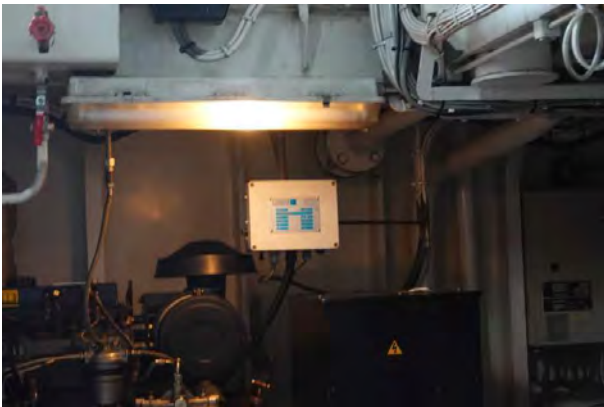
Operator					
<b>6.13</b>	Is there adequate and appropriate PPE for personnel checking/maintaining the batteries (e.g. face shields, rubber gloves)?	Yes *	No	NA	NS
Inspector	Batteries are of sealed type - maintenance-free.				
Operator					
<b>6.14</b>	Is effective emergency lighting provided to allow escape from below/under-deck/after deck to allow essential activities to be conducted?	Yes *	No	NA	NS
Inspector	Emergency lighting tested and escape route checked during the inspection.

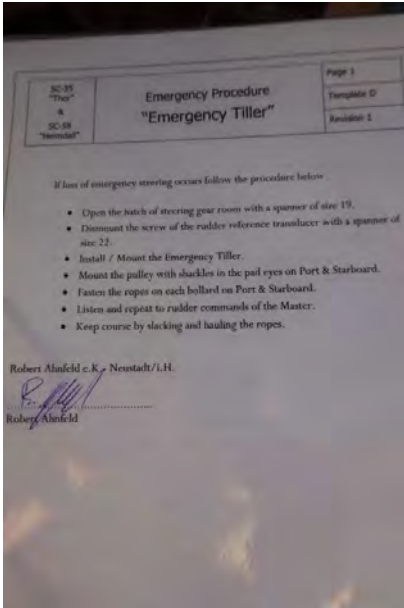
6.15	If steering by remote control, are there effective means of emergency steering?	Yes *	No	NA	NS
Inspector	<p>Switch-over on the Bridge console. 'Emergency Tiller' procedure is available (on photo).</p>

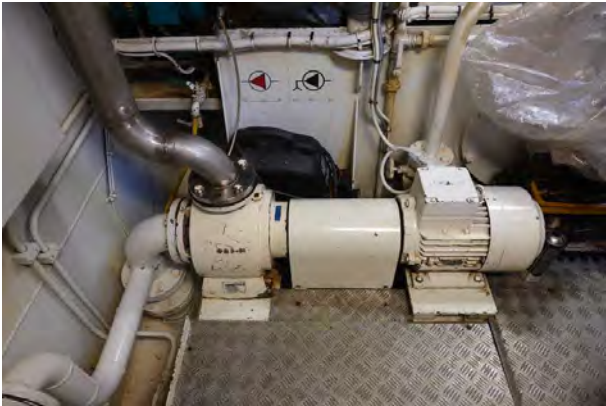
6.16	Are there two fully working bilge pumps?	Yes *	No	NA	NS
Inspector	<p>There are two fire and GS pumps in ER space.</p>

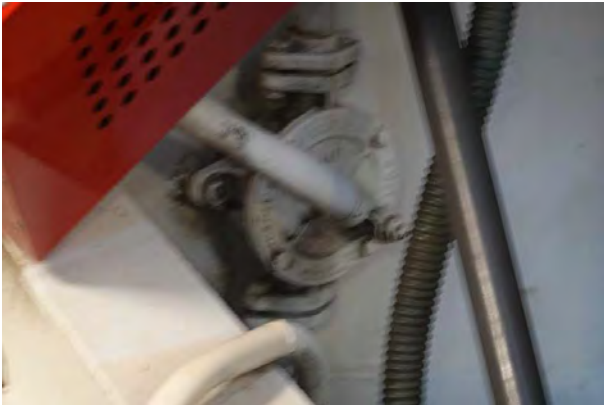
<b>6.17</b>	Is at least one bilge pump available for duty in an emergency?	Yes *	No	NA	NS
Inspector	<p>There are two Fire andf Bilge pumps. There is one hand pump (on photo), located aft of the ME.</p>

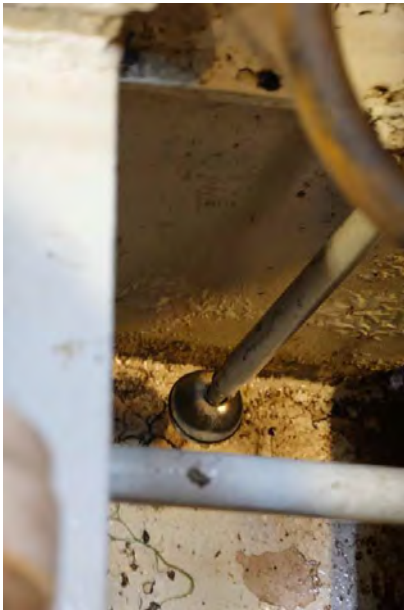
<b>6.18</b>	Is an operating bilge alarm fitted in watertight spaces containing machinery or in cargo holds?	Yes *	No	NA	NS
Inspector	<p>Bilge alarm in ER bilges tested during the inspection.</p>

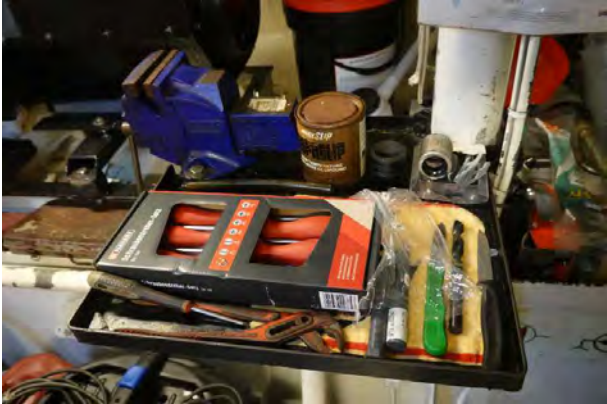
<b>6.20</b>	Are adequate tools and the manufacturers' recommended emergency spares available for the machinery?	Yes *	No	NA	NS
Inspector	<p>Basic tools and spares on board. [There is a small work bench in ER space]</p>

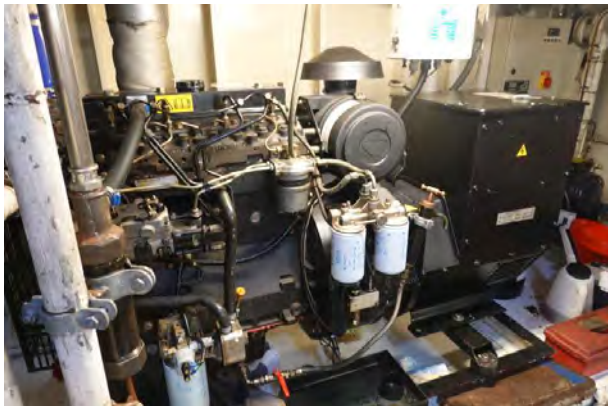
<b>6.22</b>	Is the engine room free from untreated hazards?	Yes *	No	NA	NS
Inspector	No untreated hazards identified. [Stbd side DG set is in the photo] <div style="text-align: center;">

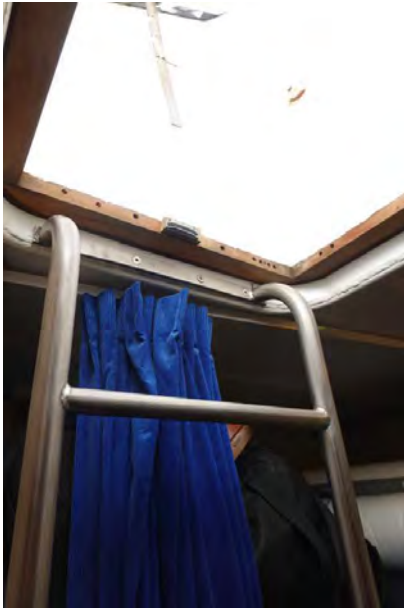
<b>9.1</b>	Are there at least two means of escape from any occupied space?	Yes *	No	NA	NS
Inspector	<p>There is only one access / exit to fish hold and net store. This spaces are only occasionally occupied. [Emergency exit from inside one of crew cabins.]</p>

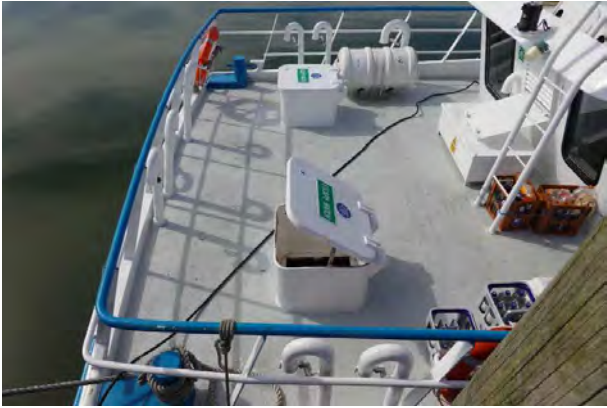
<b>9.2</b>	Are means of escape clearly marked and the escape route adequately illuminated?	Yes *	No	NA	NS
Inspector	<p>On photo are emergency exits from crew quarters, located on aft deck.</p>

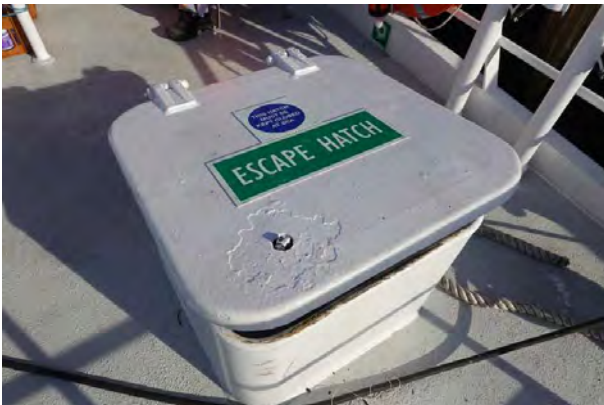
<b>9.4</b>	Additional Section 9 comments?	Yes	No *	NA	NS
Inspector	<p>[One of the emergency exits from crew cabin on aft deck. Key, for locking / un-locking from outside, is located on the Bridge.]</p>

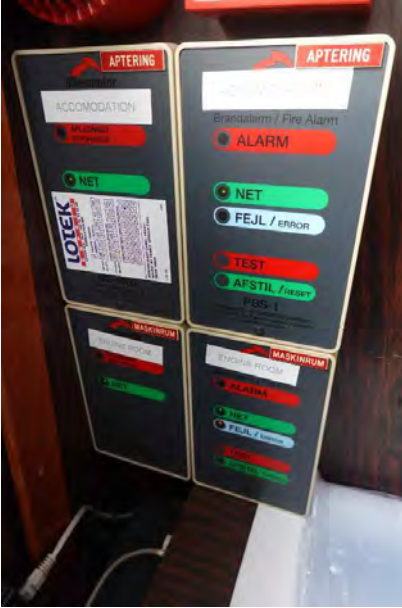
10.1	Are fire detectors and fire call points, where fitted, in working order?	Yes *	No	NA	NS
Inspector	<p>Alarm monitoring panel is on the Bridge.</p>

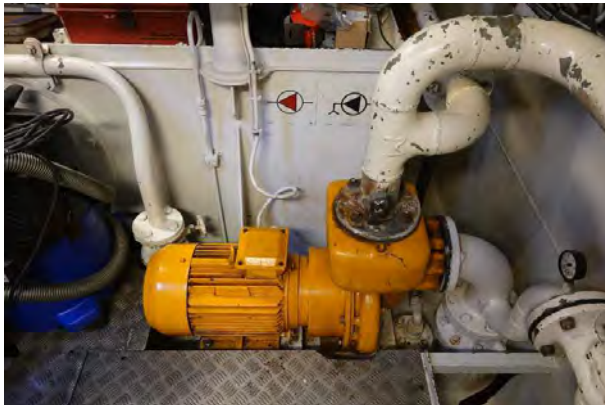
<b>10.3</b>	Is/are the vessel's fire pump(s) working and available?	Yes *	No	NA	NS
Inspector	Two Fire and GS pumps are located in ER space,

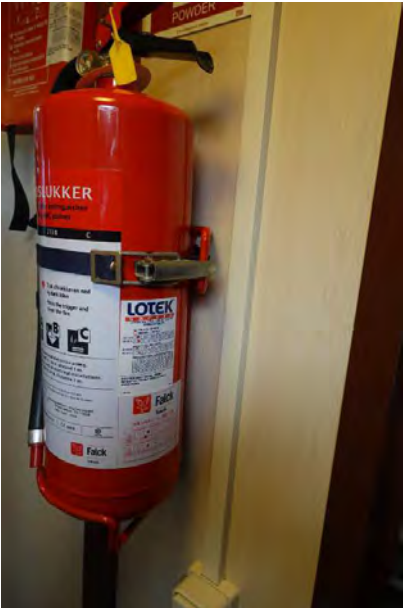
10.7	Are the required number and correct type of portable fire extinguishers available on the vessel as defined in the safety plan and with valid service certificates?	Yes *	No	NA	NS
Inspector	<p>Portable extinguishers available as per Safety and Fire plan.</p> <p>Portable extinguishers:</p> <p>6 x 6kg DP</p> <p>1 x 5kg CO2</p> <p>1 x 2 kg CO2</p> <p>Last inspection by authorized company: 02/ 2023</p>

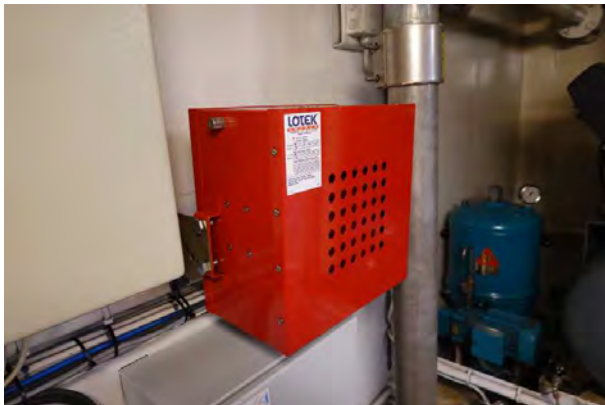
<b>10.8</b>	Is there a fixed firefighting system for the engine room?	Yes *	No	NA	NS
Inspector	STAT-X, with two distributors. Last inspection: 02/ 2023

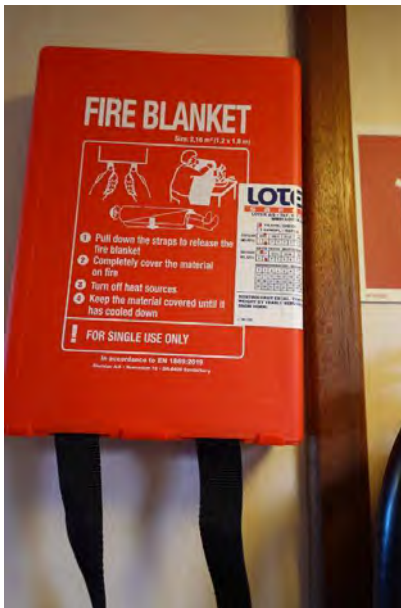
<b>10.9</b>	Is there a fire blanket in the galley/pantry/cooking area?	Yes *	No	NA	NS
Inspector	Fire blanket is in place.

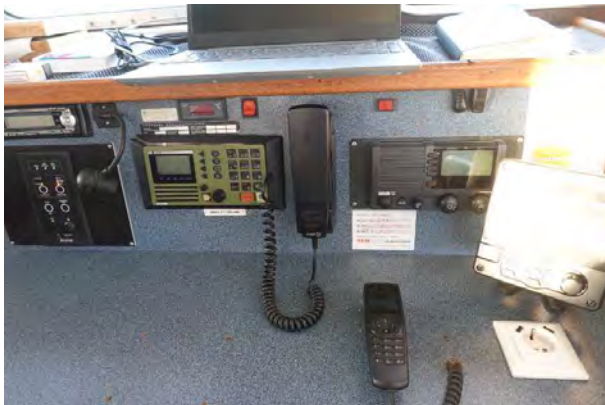
<b>11.2</b>	Has the vessel had a recent Class radio survey, or radio verification report (eg. Mecal), or annual UK Code survey which physically tested the equipment?	Yes *	No	NA	NS
Inspector	Last GMDSS radio survey performed: 2023-08-23 (by Horn) [On the photo is a part of the Bridge console, with comm. equipment]

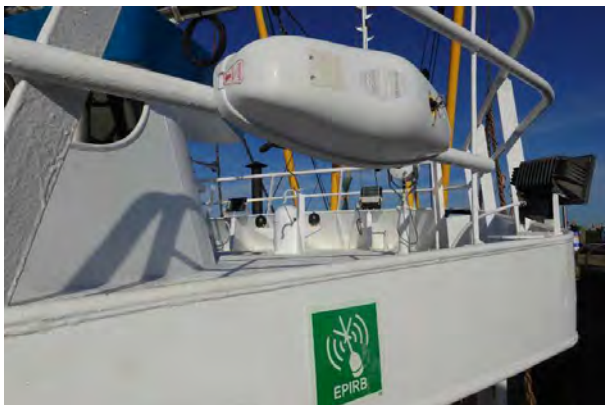
<b>11.4</b>	Is an emergency position indicating radio beacon (EPIRB) fitted? Is the hydrostatic release unit (HRU) fitted correctly?	Yes *	No	NA	NS
Inspector	Last annual inspection: 2023-03-07

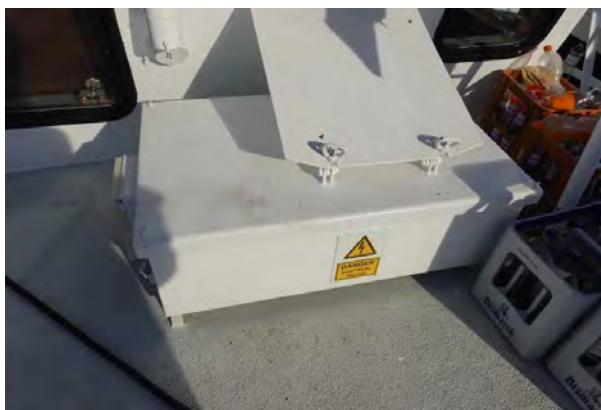
Batteries located on deck aft of the Bridge.

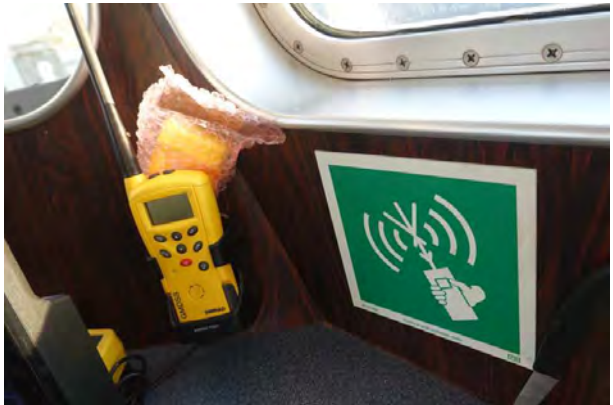
<b>11.11</b>	Are sealed spare batteries for the hand held VHF radio(s) available and charged?	Yes *	No	NA	NS
Inspector	Portable GMDSS Radios batteries: 07/2025

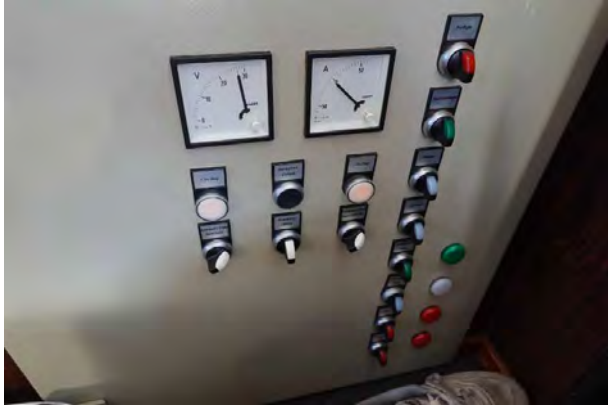
<b>12.1</b>	Are navigation lights in good working order?	Yes *	No	NA	NS
Inspector	<p>Navigation and signal lights tested during the inspection and found in order. [On photo is a lights panel on the Bridge]</p>

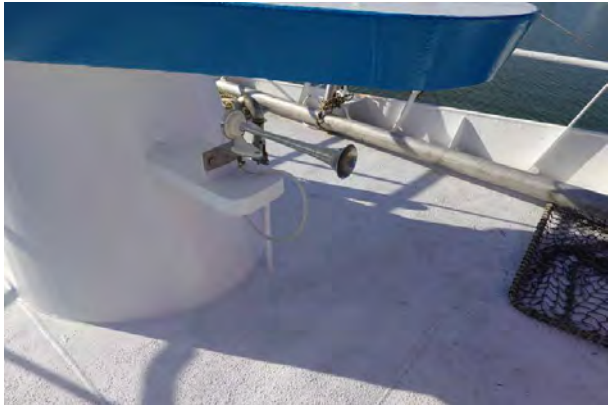
<b>12.2</b>	Is there a means of making an efficient sound signal?	Yes *	No	NA	NS
Inspector	<p>Horn, located abaft the Bridge.</p>

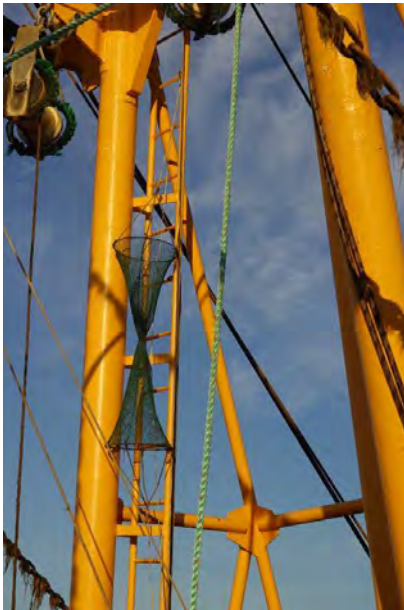
<b>12.3</b>	Are navigational day shapes available?	Yes *	No	NA	NS
Inspector	Day shapes are available

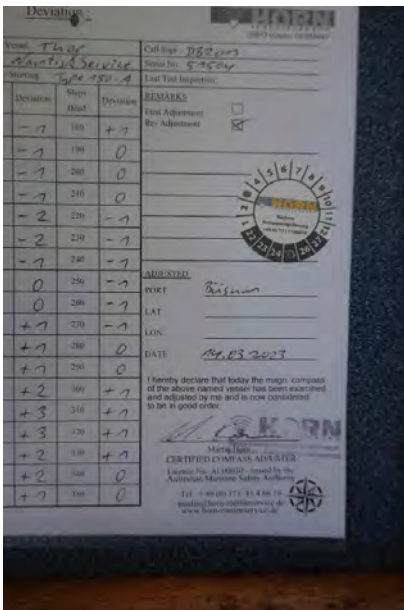
<b>12.4</b>	Is the magnetic compass in working order?	Yes *	No	NA	NS
Inspector	Last deviation card issued: 2023-03-14 (by Horn)

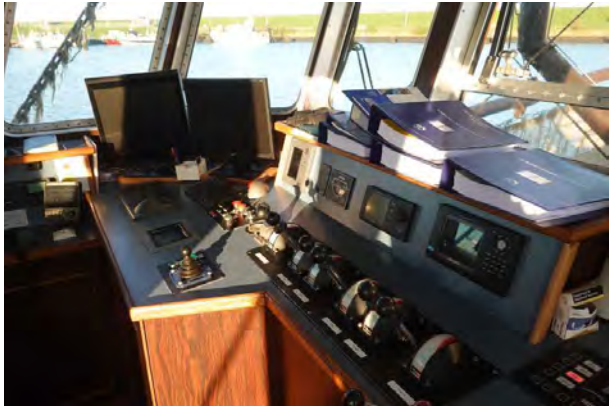
<b>12.5</b>	Is a global navigation satellite system or a terrestrial radio navigation system available?	Yes *	No	NA	NS
Inspector	1 x GPS - Operational [Part view of the Bridge console]

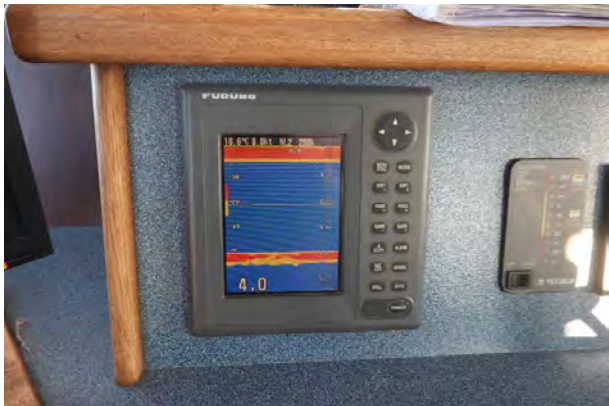
<b>12.7</b>	If an echo sounder is fitted is it in working order?	Yes *	No	NA	NS
Inspector	Seen in operation

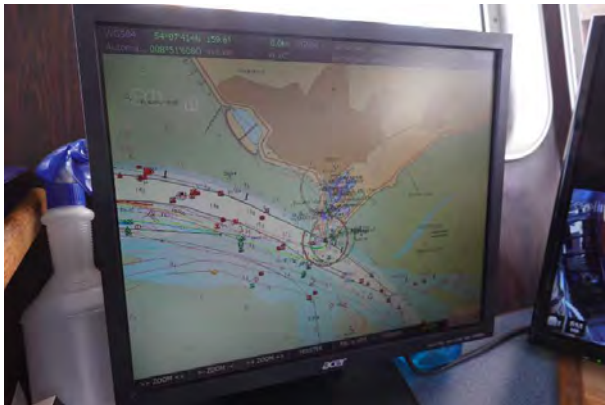
12.8	Are approved, current, corrected charts available?	Yes *	No	NA	NS
Inspector	Charts on board for area of operation. ECDIS on board.

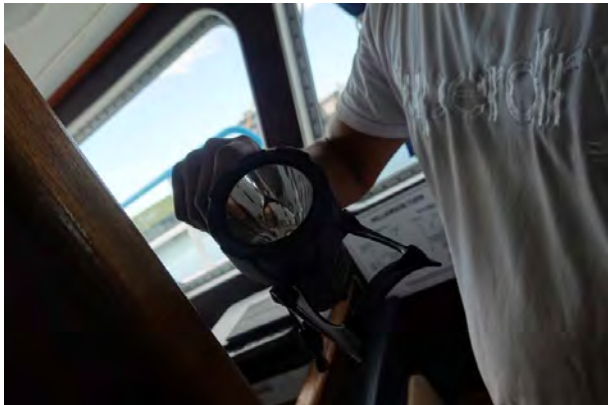
<b>12.10</b> Is an efficient waterproof signalling lamp suitable for Morse signalling provided?		Yes	No	NA *	NS
Inspector	Portable lamp available.

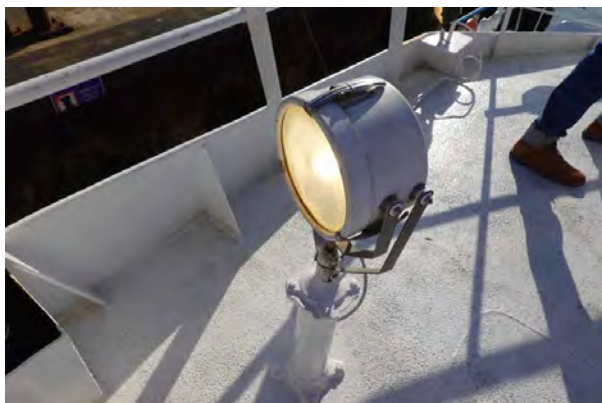
Inspector There is one fixed search-light, located above the Bridge. This was tested during the inspection. There are also flood-lights to illuminate main deck and sides areas.

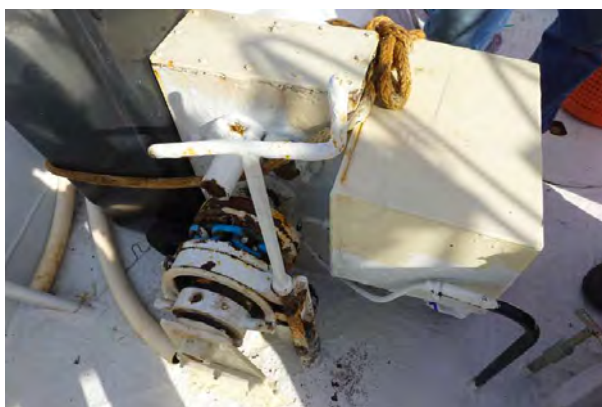
Inspector There is an anchor winch and anchor. There is a spare anchor in Net Store. Spare anchor was not readily accessible, as it was obstructed by various gear (See Summary Page).

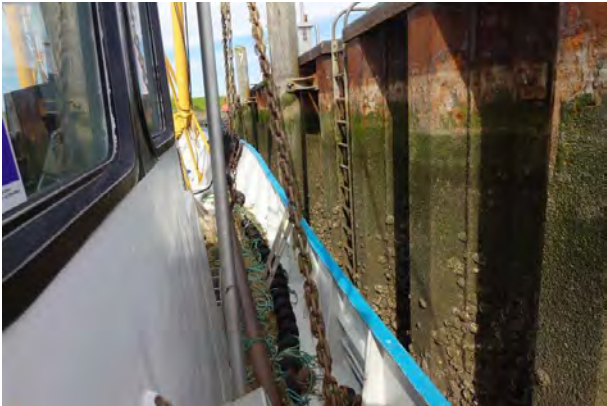
<b>15.2</b>	Is there a safe means of access to and from the vessel?	Yes *	No	NA	NS
Inspector	<p>Access was directly from the dock, over ladder. There is no gangway on board.</p>

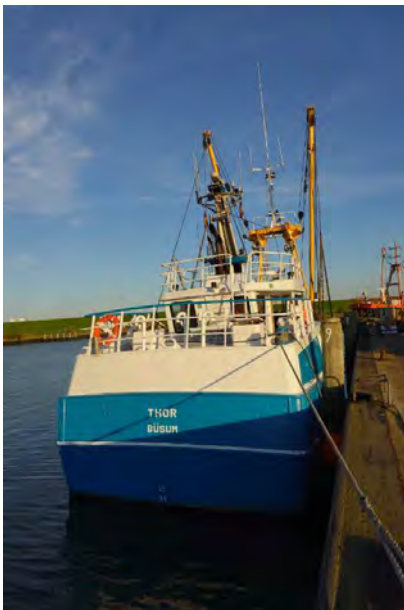
Inspector	Guard rails on the deck behind the Bridge are adequate.

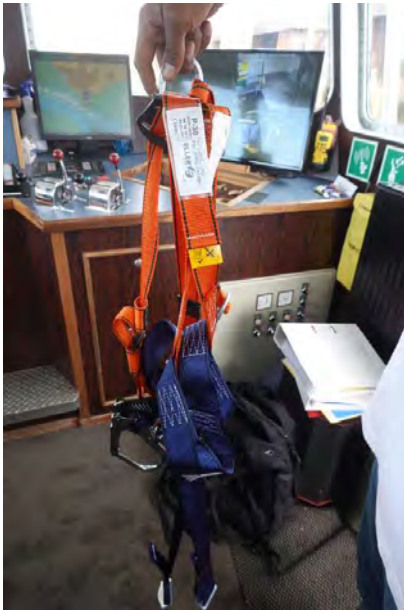
<b>15.12</b>	Are there at least two safety harnesses onboard and additional harnesses for all those required to work on deck?	Yes *	No	NA	NS
Inspector	2 Safety harnesses available. <div style="text-align: center;">

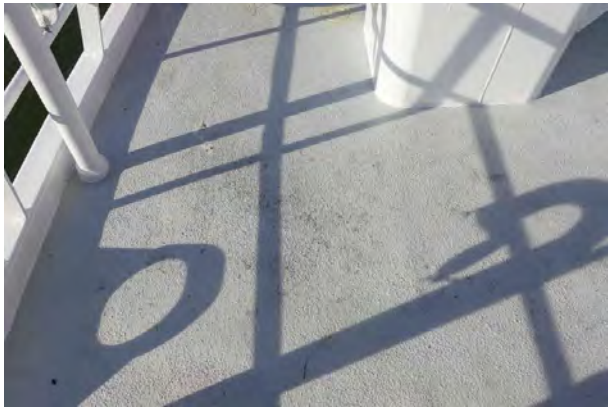
<b>15.13</b>	Is the surface of the working deck non-slip?	Yes *	No	NA	NS
Inspector	Working deck and the deck behind the Bridge are non-skid coated. Outside ladders (to Bridge deck) are steep but in good condition. <div style="text-align: center;">

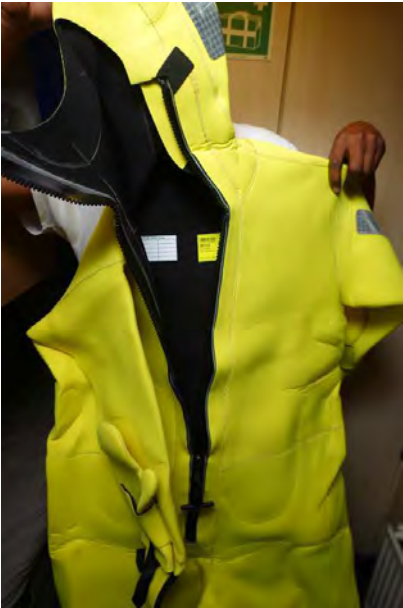
15.15	If the mean seawater temperature is 15°C or less, is there an approved survival suit for each person onboard?	Yes *	No	NA	NS
Inspector	<p>There are 6 immersion suits on board. Last 3 year inspection: 02/2023. Immersion suits were checked for possible damage, and found in good condition.</p>

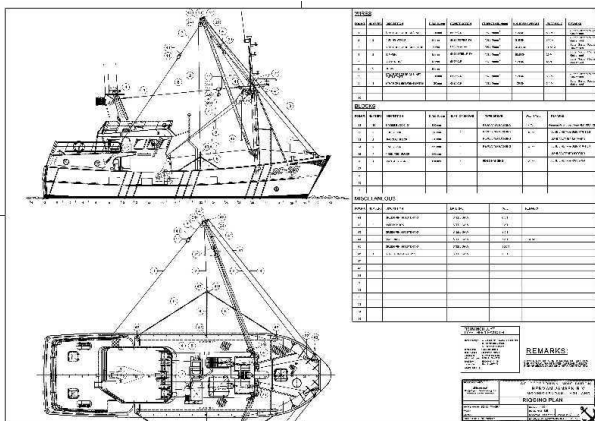
Inspector	Derick wires and chains are in good condition. There is an elaborate management plan on board for dericks and the equipment (Rigging Plan is on photo)
Operator

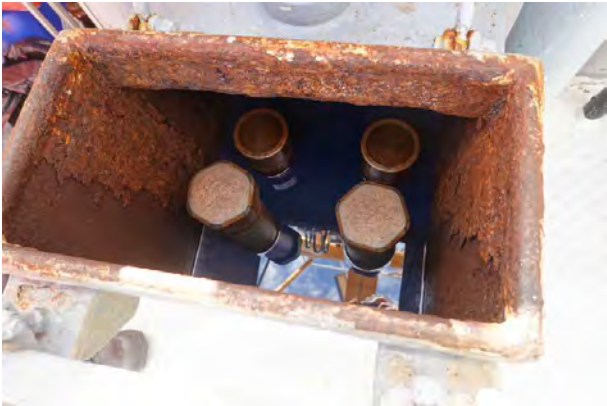
19.4	Are arrangements in place for the handling of oily wastes?	Yes *	No	NA	NS
Inspector	<p>Any oily waste is discharged ashore. No ORB kept, but bunker receipts available. Note: there was some oil in the Bunker manifold save-all, which can be weather-tight closed (see Summary page).</p>

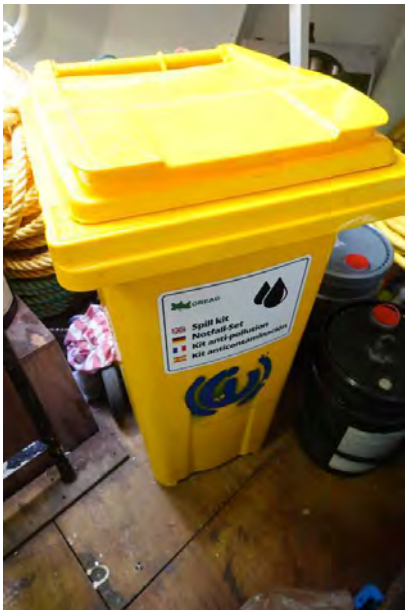
19.5	Are arrangements in place for the prevention of discharge of oil/oil-contaminated water overboard?	Yes *	No	NA	NS
Inspector	<p>SOPEP equipment available. Located in Nets store. Note: There is no SOPEP kit identification sticker on the entrynce hatch cover.</p>

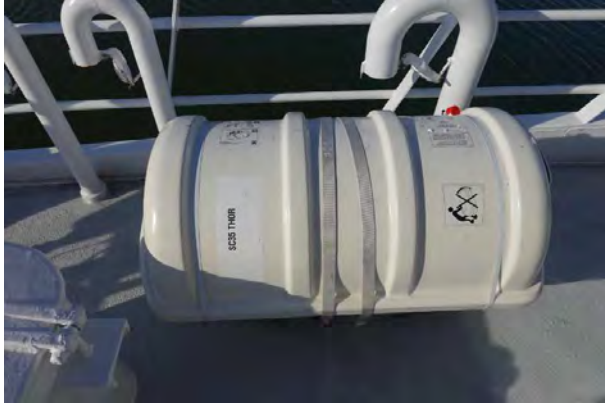
<b>20.1</b>	Is/are there a life raft(s) onboard sufficient for the proposed maximum POB?	Yes *	No	NA	NS
Inspector	<p>There is 1 x 6 persons life rafts on stbd side  Next inspection: 07/2024 ; HRU: 07/2024  There is 1 x 6 persons life rafts on Port side (on photo)  Next inspection: 09/2025 ; HRU: 09/2025</p>

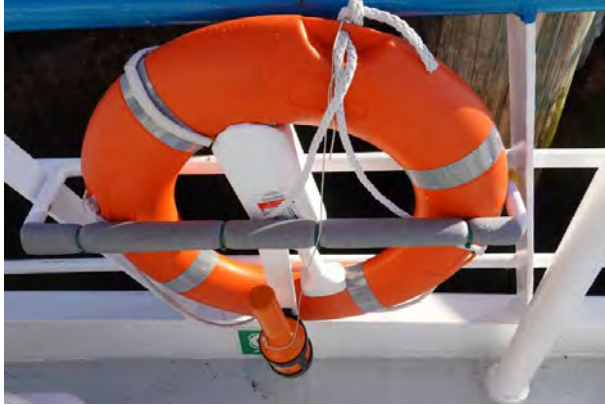
<b>20.2</b>	Are the number and type of life buoys as required and are they in satisfactory condition?	Yes *	No	NA	NS
Inspector	<p>2 pcs - As per Safety Equipment Certificate.</p>

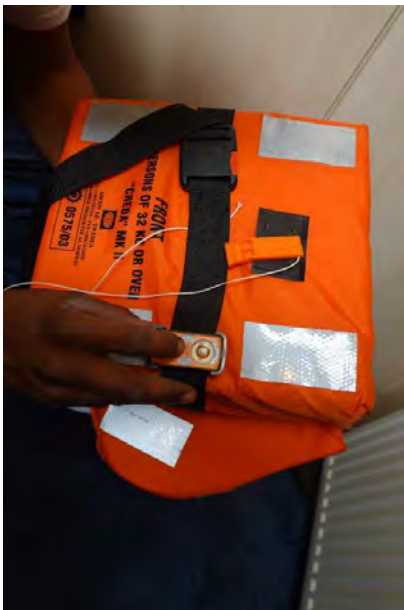
<b>20.3</b>	Is there an approved life jacket for every person carried on the vessel?	Yes *	No	NA	NS
Inspector	6 x Life jacket Lj. lights: 12/2027 4 x inflatable work vests, Next inspection: 04/2024

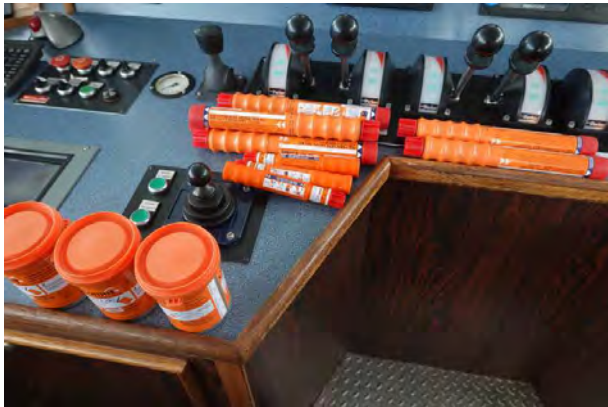
<b>20.4</b>	Are there the required number and type of pyrotechnic distress signals onboard the workboat?	Yes *	No	NA	NS
Inspector	6 x Parachute flares: 07/202 6 x Hand flares: 10/2025 3 x Smoke signals: 07/2026

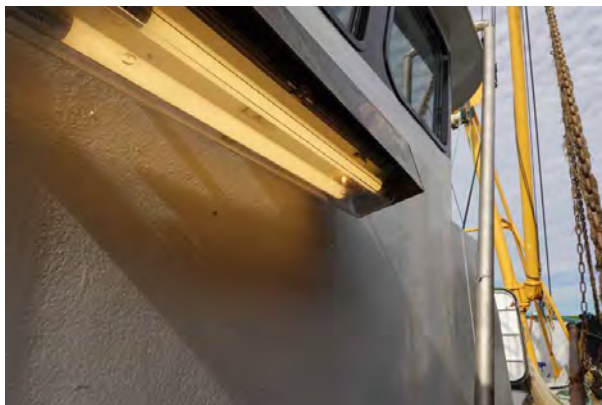
Inspector Checked during the inspection. 24 V system.

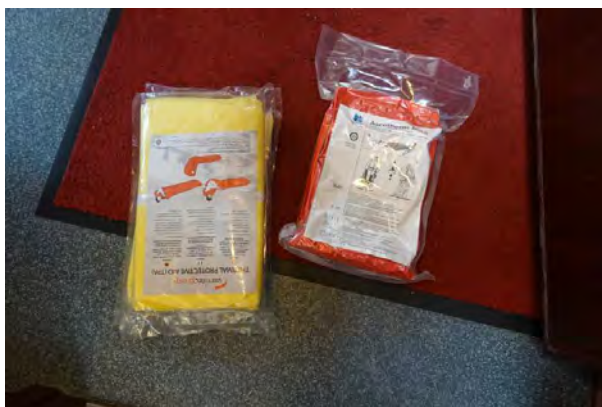
Inspector 4 pcs on board

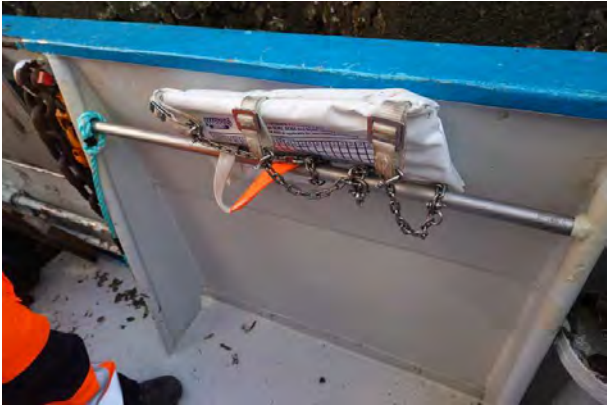
<b>20.8</b>	Are there effective means to recover a person from the water?	Yes *	No	NA	NS
Inspector	<p>There is:</p> <ul style="list-style-type: none"> <li>- Rescue sling</li> <li>- Marcus rescue ladder (on photo)</li> </ul>

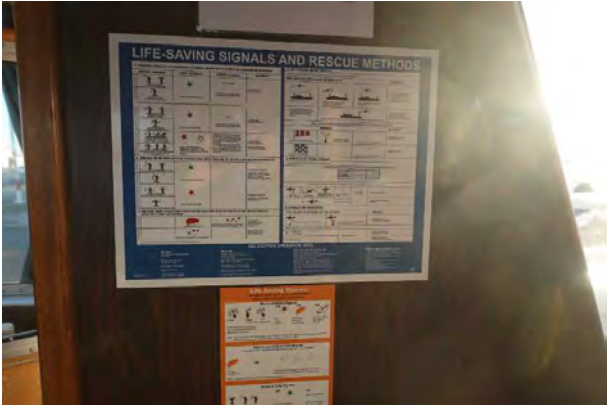
<b>20.9</b>	Are life-saving signal tables available?	Yes *	No	NA	NS
Inspector	<p>Posted on the Bridge</p>

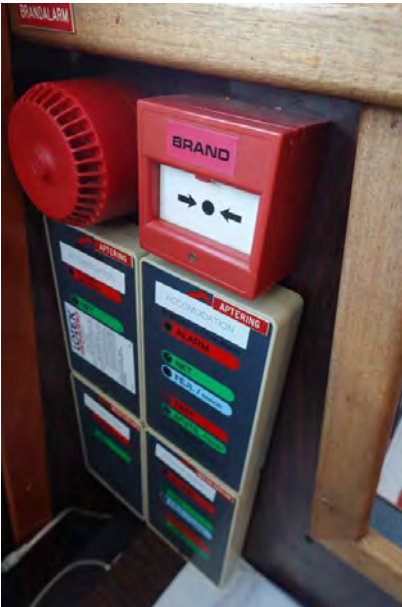
<b>20.10</b>	Is there a means of sounding a general alarm in the event of an emergency?	Yes *	No	NA	NS
Inspector	<p>Alarm pannel and push-button on the Bridge.</p>

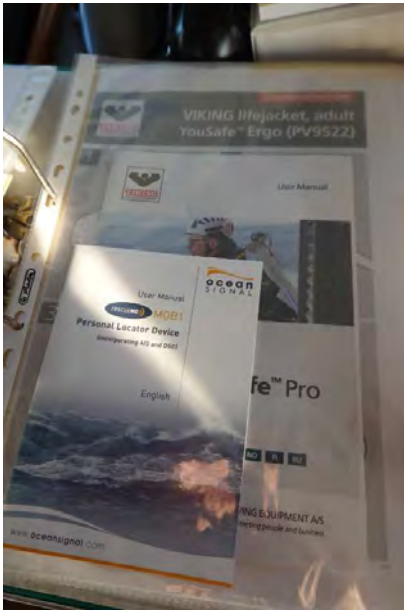
20.11 Is there a training manual for use of life saving appliances (LSA)?		Yes *	No	NA	NS
Inspector	<p>Procedures and equipment manuals.</p>

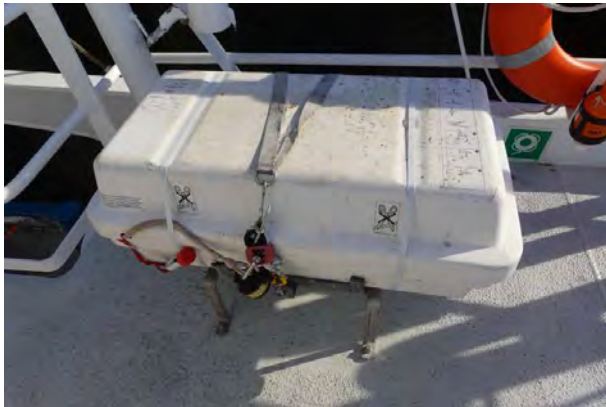
20.13 Additional Section 20 comments?		Yes	No *	NA	NS
Inspector	<p>[Stbd side life raft is on the photo]</p>

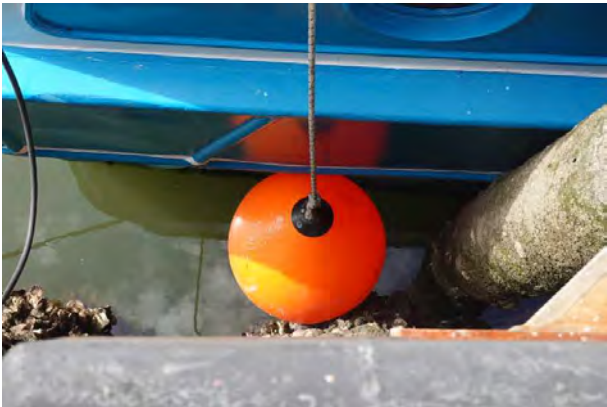
<b>21.4</b>	Is adequate fendering available?	Yes *	No	NA	NS
Inspector	Inflatable fenders in use.

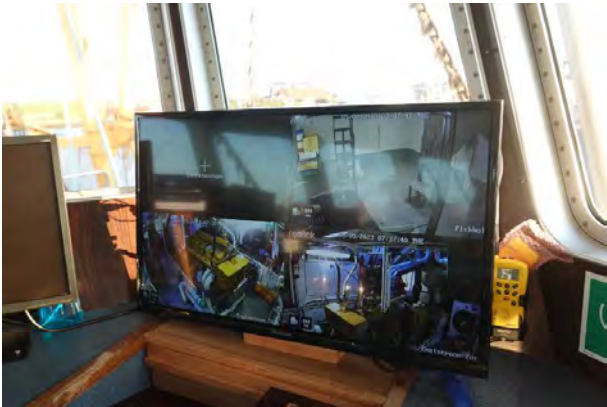
22.3	Does the vessel have specific port security procedures covering visitors, storing and vessel gangway watchkeeping requirements?	Yes	No	NA *	NS
Inspector	<p>There is a CCTV in use. Bridge monitor is on the photo.</p>

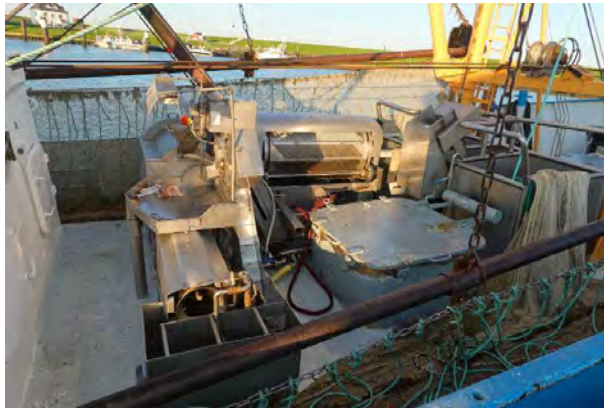
**Photo 5**

Inspector Working deck. Entrance hatch to fish hold can be seen.

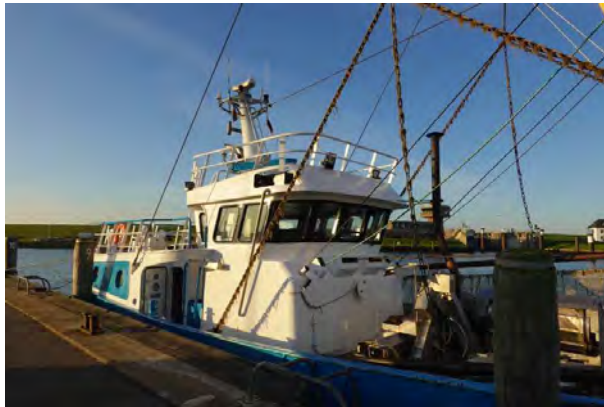
**Photo 6**

Inspector View towards deck house and aft quarters.

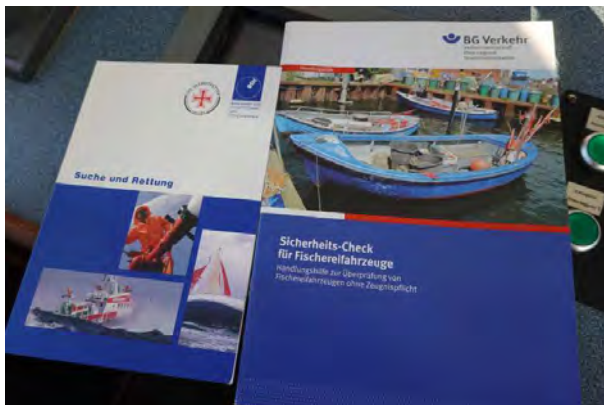
**Photo 7**

Inspector Part of the ships library - Safety checks and Search and Rescue booklet.
